M6™ Controller

Digital Belt stiffness problems

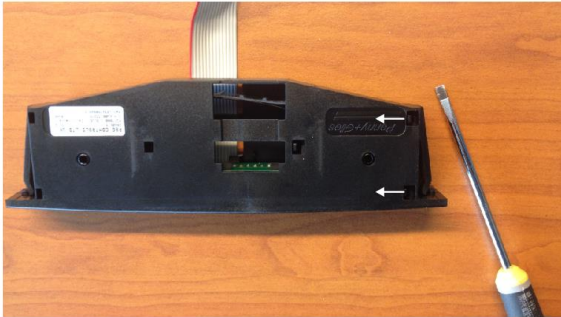
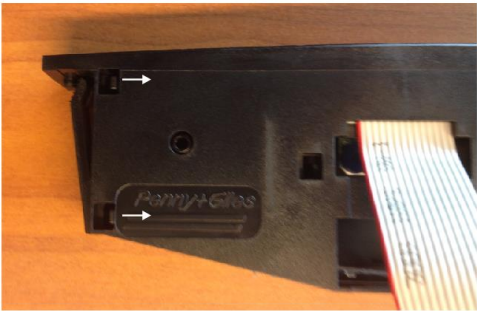
In some M6™ controllers (also Maxxyz Compact and Programmer modules), the Digital Belts may jump back or jump forward to certain positions. The cause: the digital belts have been left too long in a certain position so that the ribbon belt is deformed.

1. Open the belt: push the clips inside.
Use a small flat screwdriver.
