MAC 301 Reset modification

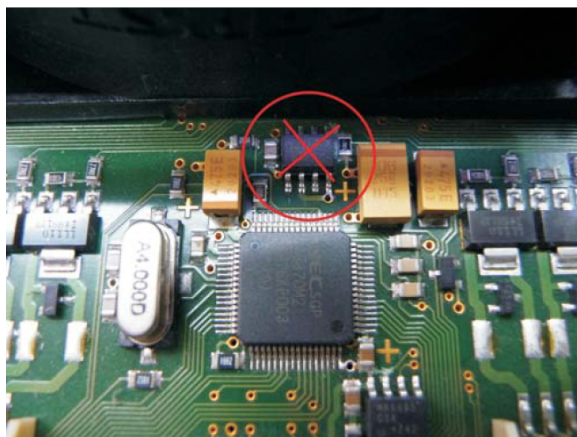
On some early MAC 301s, the LED, zoom and fans on the units could shut down for no reason. Our investigations suggest that this is due to slight corrosion on the connectors which connect the power supply to the LED driver board and the P/T processor board. On these boards, there is a reset IC which triggers at a relatively high level (approx. 4.6 V). If there is a bad connection to the power supply and this voltage is sensed by the reset IC, it will trigger and send reset commands to the CPU.

1. Follow the safety precautions in the MAC 301 user manual.
2. Remove the rear head cover and yoke covers.
3. Remove the reset IC ADM 705 from the head PCB JBL0106.
