Update Instructions for V4.9.x.xxx Vi1 and Vi2/4/6 consoles

V1.1 22-08-2017

Appendix 1: Vi2/4/6 Master Bay jumper change for V4.9.x software update

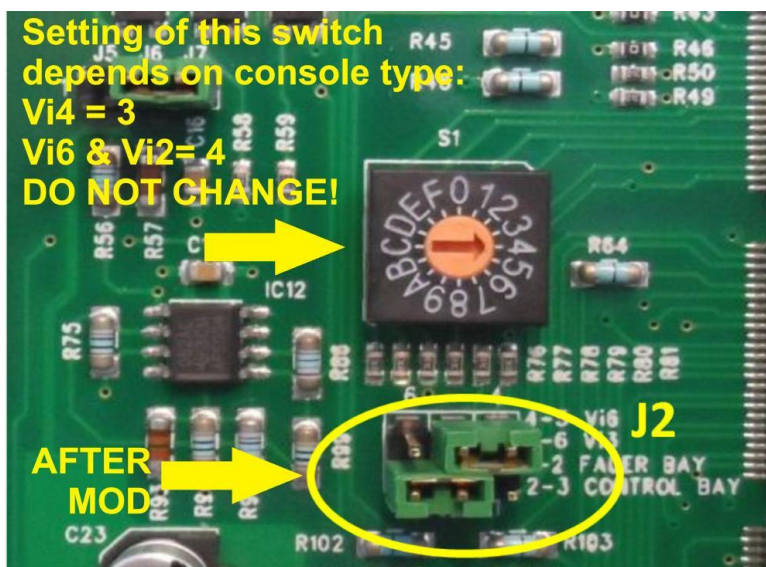
Fig. 2
Close-up of Jumper group J2
Move the upper jumper to the right, so it is in the 4-5 position. Leave the lower jumper in the left-hand (2-3) position. After the change, the jumpers should look like they do in the photo.
Note: On all Control Boards other than the Master, **both** jumpers will already be set to the right-hand position, this is correct and does **not** need to be changed.

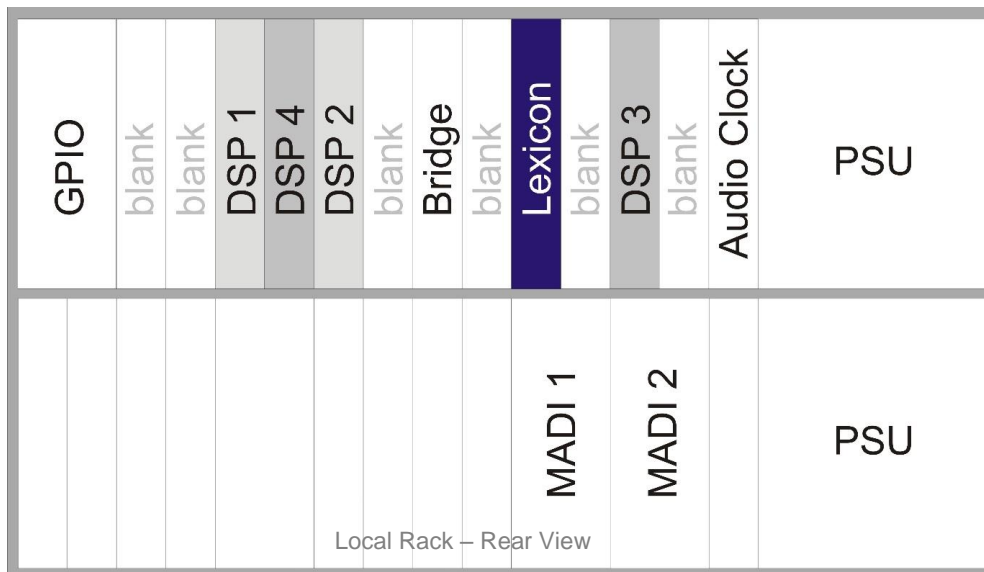
If any of the cards are not fitted in the correct locations (due to incorrect installation in the field or after refitting following service work), this will likely result in failure of the rack to pass audio in one way or another after the console is updated to V4.9.x

The diagram below shows the position of up to 4 DSPs plus the Lexicon card.
If your rack has less than 4 DSPs, ignore cards 3 and/or 4.

Check DSP and Lexicon card locations match the following and if different, move the cards to the indicated positions:
