Update Instructions for V4.9.x.xxx Vi1 and Vi2/4/6 consoles

V1.2 13-07-2018

Vi2/4/6 Master Bay jumper change for V4.9.x software update

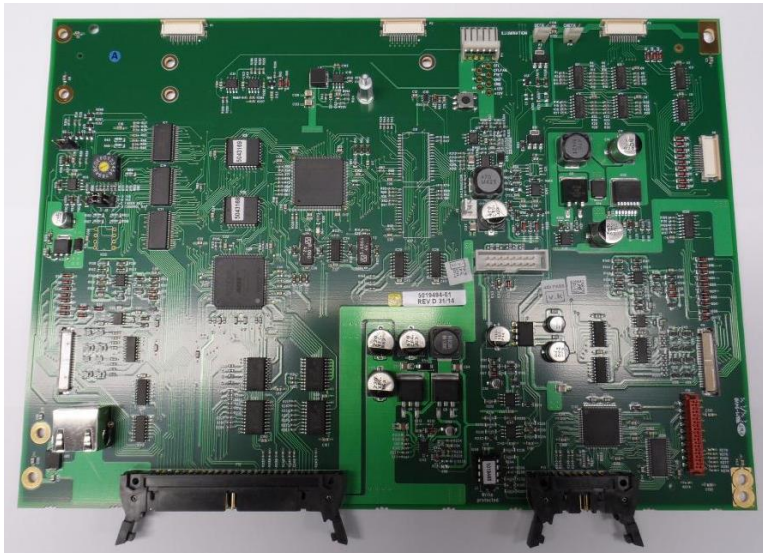
If you install the 4.9.x update but do not change the jumper setting, the console may appear to work normally initially, however undesirable behaviour will come to light at some stage. The problem will be that the faders in the Master (Control) Bay will experience erratic operation, with some faders jumping up or down, either when a show is loaded or when Gang mode is used.

Fig. 1
Location of the jumper group J2 on the Control Board mounted behind the Master TFT screen.

1. Gain access to the rear of the console and remove the 9 screws securing the **left-hand** rear access panel (as you look at the rear of the console). Lower the rear panel to allow access to the Control boards, which are the PCBs mounted directly behind the TFT screens.
2. On the Master Bay Control Board **only** (the right-hand of the two Control boards visible as you look at the back of console), locate the pair of jumpers labelled **J2**. There are two jumpers in this group, one labelled 1-2-3 the other 4-5-6. See Fig 1 below for the location.
3. These jumpers will be fitted bridging pins 2-3 and 5-6. Move the **upper** jumper only, from the 5-6 position to the 4-5 position, as per Fig 2 below. Note that this change should **only** be done on the Master Bay Control board.
4. Close up the rear access panel and carry out the software update to V4.9.0 if not already done.

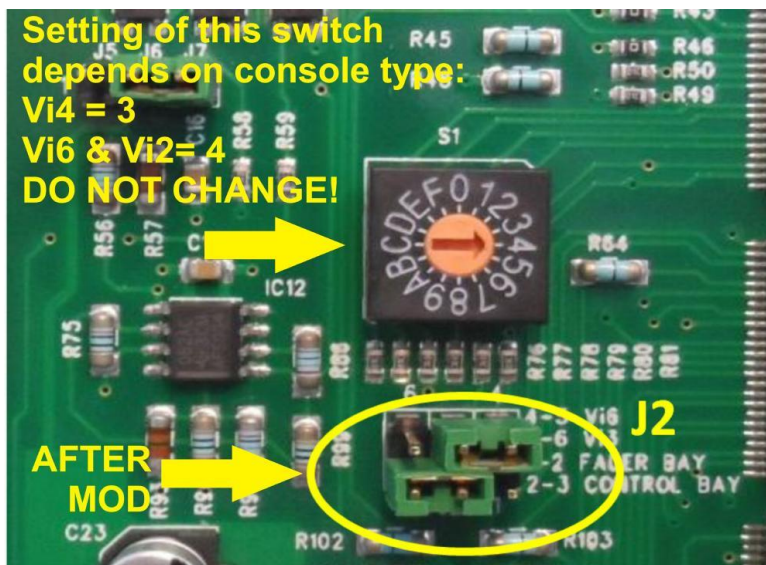
Fig. 2
Close-up of Jumper group J2
Move the upper jumper to the right, so it is in the 4-5 position. Leave the lower jumper in the left-hand (2-3) position. After the change, the jumpers should look like they do in the photo.
Note: On all Control Boards other than the Master, **both** jumpers will already be set to the right-hand position, this is correct and does **not** need to be changed.

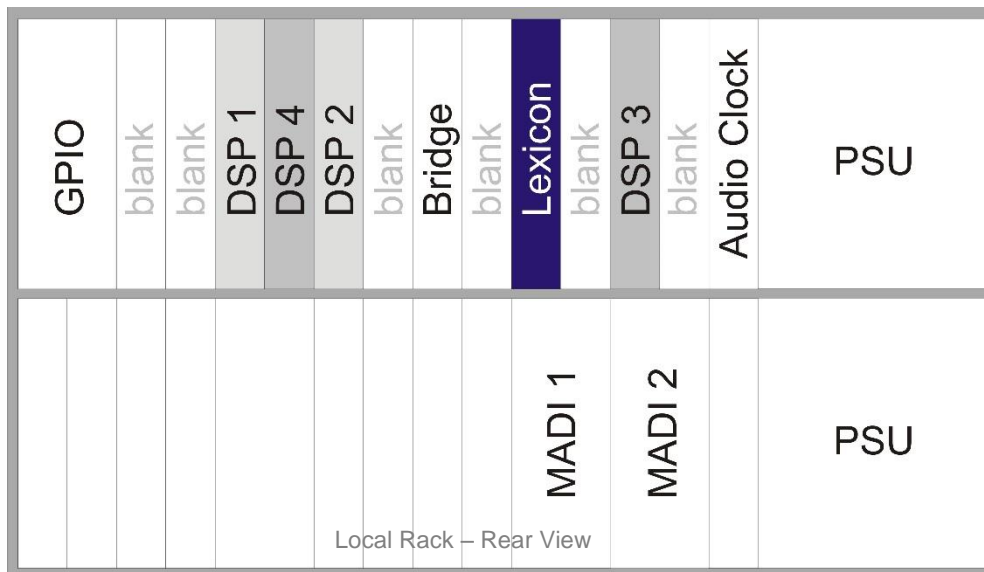
With the release of V4.9,x software for Vi2/4/6, the DSP and FX cards must be in the correct factory default locations. This did not matter on earlier software releases and as a result, it is possible that some Local Racks will have non-standard locations of these cards which has not been noticed since it did not cause any problems in the past.

If any of the cards are not fitted in the correct locations (due to incorrect installation in the field or after refitting following service work), this will likely result in failure of the rack to pass audio in one way or another after the console is updated to V4.9.x

The diagram below shows the position of up to 4 DSPs plus the Lexicon card.
If your rack has less than 4 DSPs, ignore cards 3 and/or 4.

Check DSP and Lexicon card locations match the following and if different, move the cards to the indicated positions:

1. Switch off the Local Rack. Unscrew the 2 small screws top and bottom to release the card fascia. Pull on the two large elongated screws to remove the card from the backplane and slowly slide out.

2. To refit cards, hold the card the right way up, engage the PCB carefully with the mounting rails and slide the card slowly into the rack, taking great care not to let components on the left hand side of the card catch on the adjacent metal panels.
